# **U.S. Aircraft Carriers**

## **in action Part 1**

**By Robert Stern**  
**Color by Don Greer**  
**Illustrated by Joe Sewell**

**Warships Number 5**  
**squadron/signal publications**

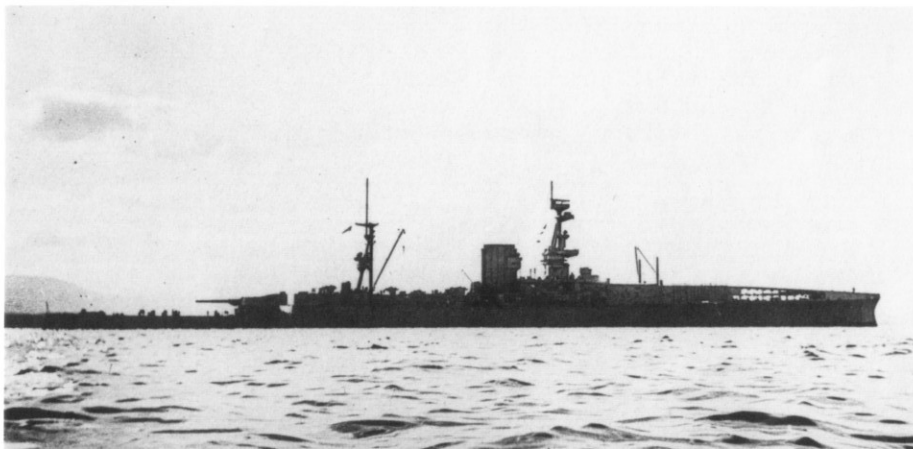
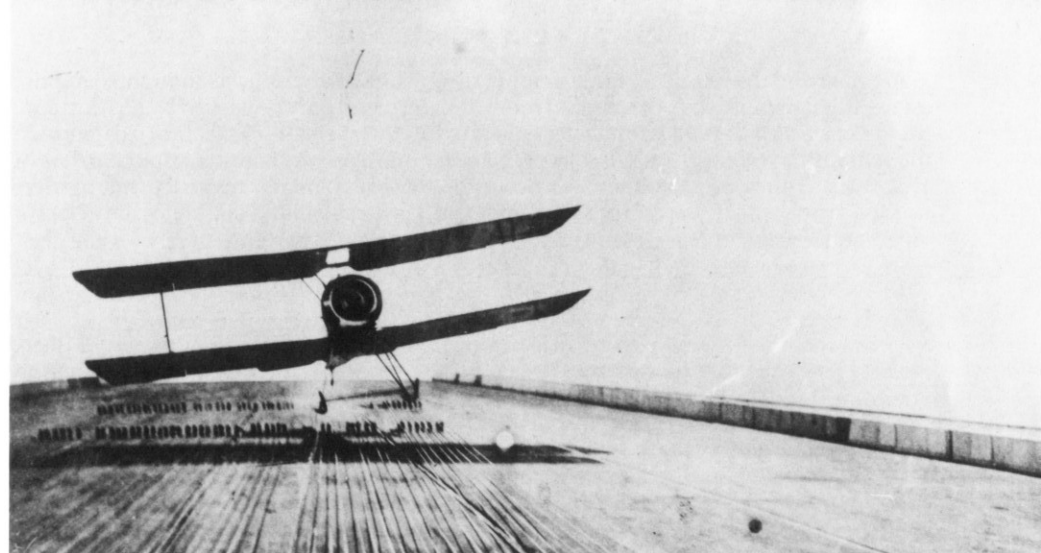
**The first dedicated aircraft carrier in the world was the Royal Navy's HMS FURIOUS. FURIOUS was launched during 1916 with a flying off deck forward, which displaced one of her two gun turrets. She retained her aft gun turret. (USAF)**

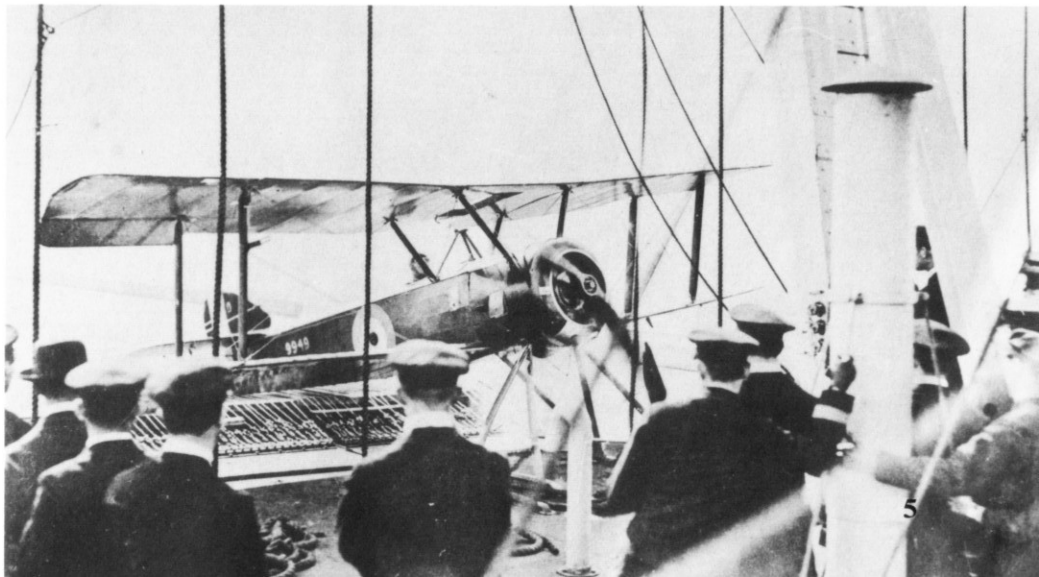
**This Sopwith Pup missed the wires and engaged a rope barrier strung across the deck to keep the Pup from crashing into the ship's mainmast. Barrier crashes were embarrassing and could result in damage to both pilot and aircraft. (USAF)**

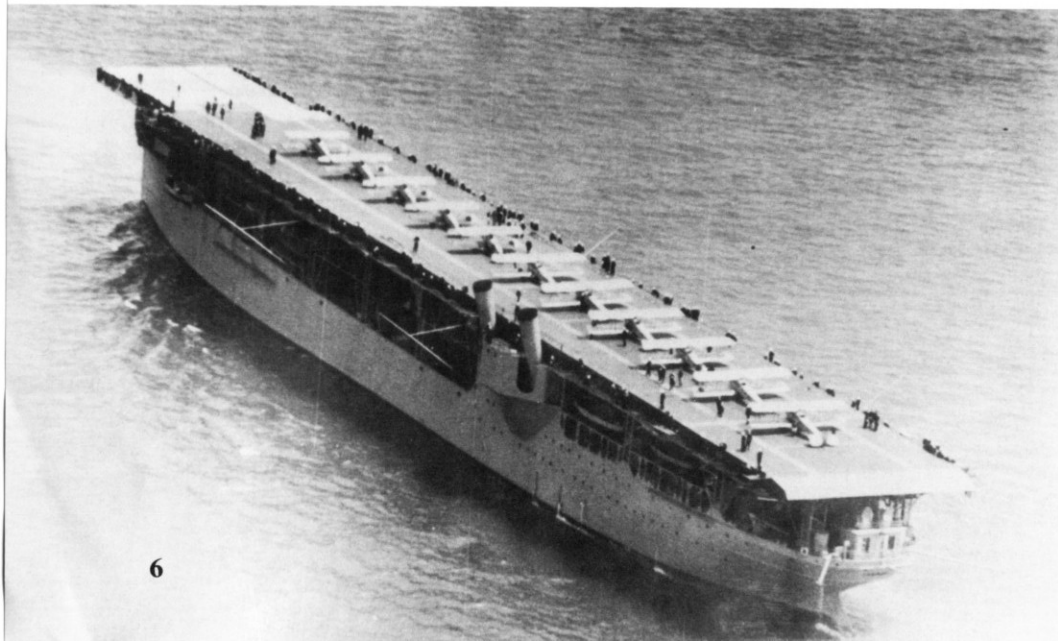
**LANGLEY**

**Early in her career, USS LANGLEY had a large pigeon coop under the flight deck round down. The coop held homing pigeons to carry messages. The pigeon coop was deleted soon after her launch. The two stacks folded down during flight operations. (NARA)**

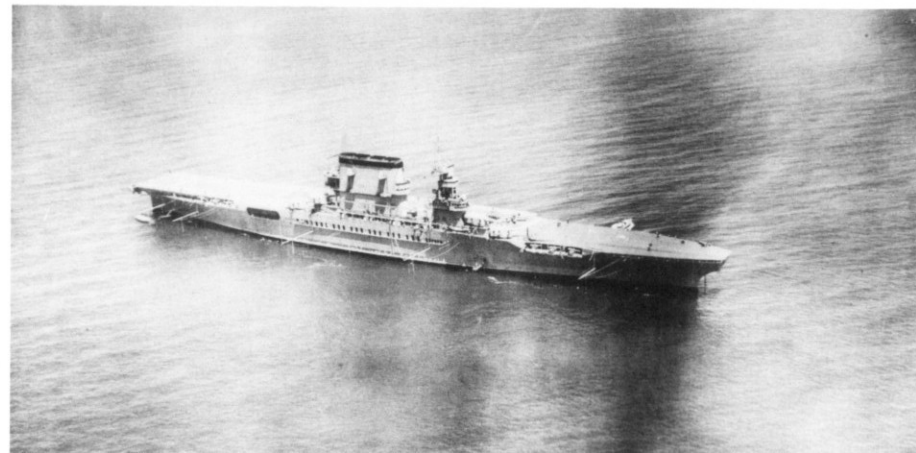
The small boat booms were deployed while USS LEXINGTON was at anchor during 1928. The ship's clean hull was a holdover from its battlecruiser design, which caused space in the hangar deck to be limited. The ship was armed with twin 8 inch gun turrets mounted forward and aft of the island. (USAF)

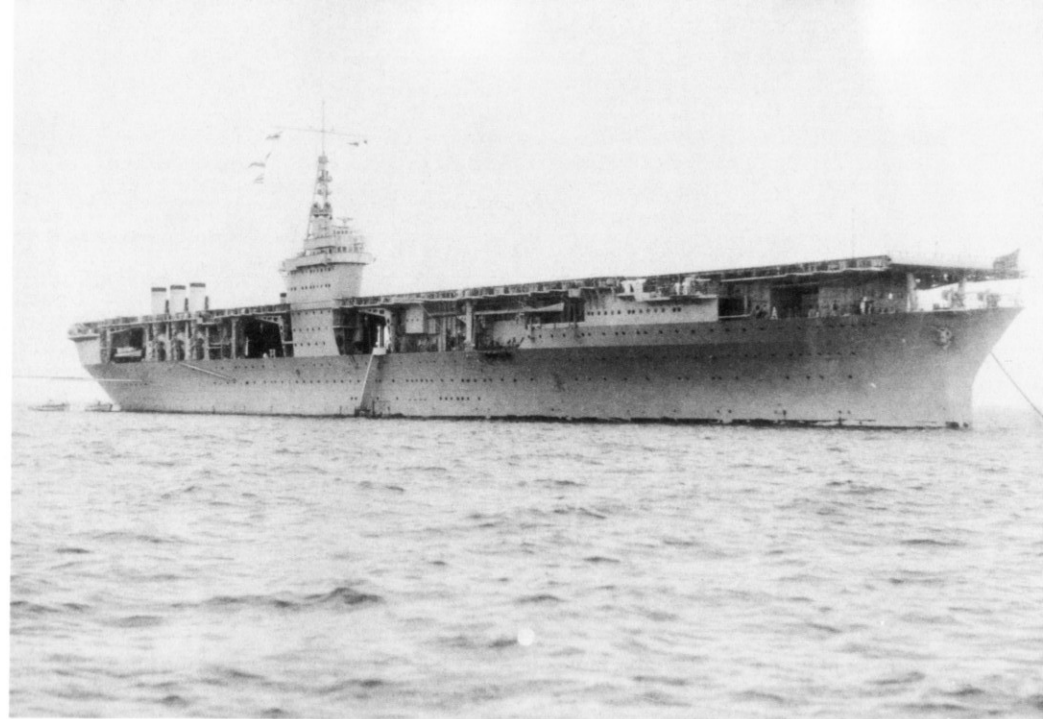
**USS RANGER rests at anchor on 11 August 1934; she is largely unchanged since her launch. Her most distinguishing characteristic was the arrangement of six folding funnels, three on each side, aft of her small tower bridge. (NARA)**

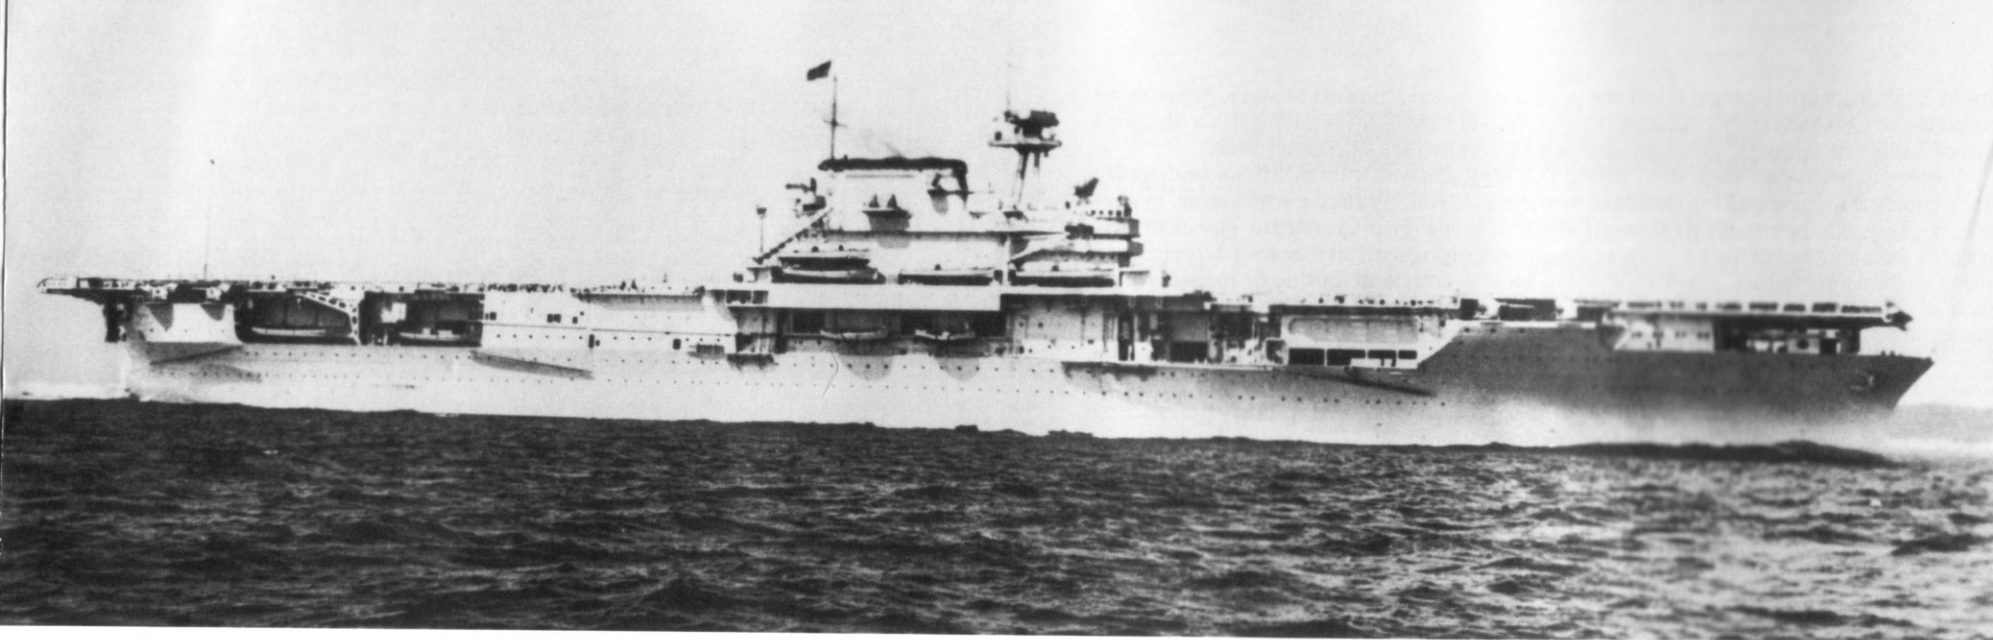
Were it not for the considerably more massive island structure incorporating the funnel, the YORKTOWN class would be hard to distinguish from USS RANGER. The YORKTOWN class was basically an enlarged version of the RANGER. (USAF)

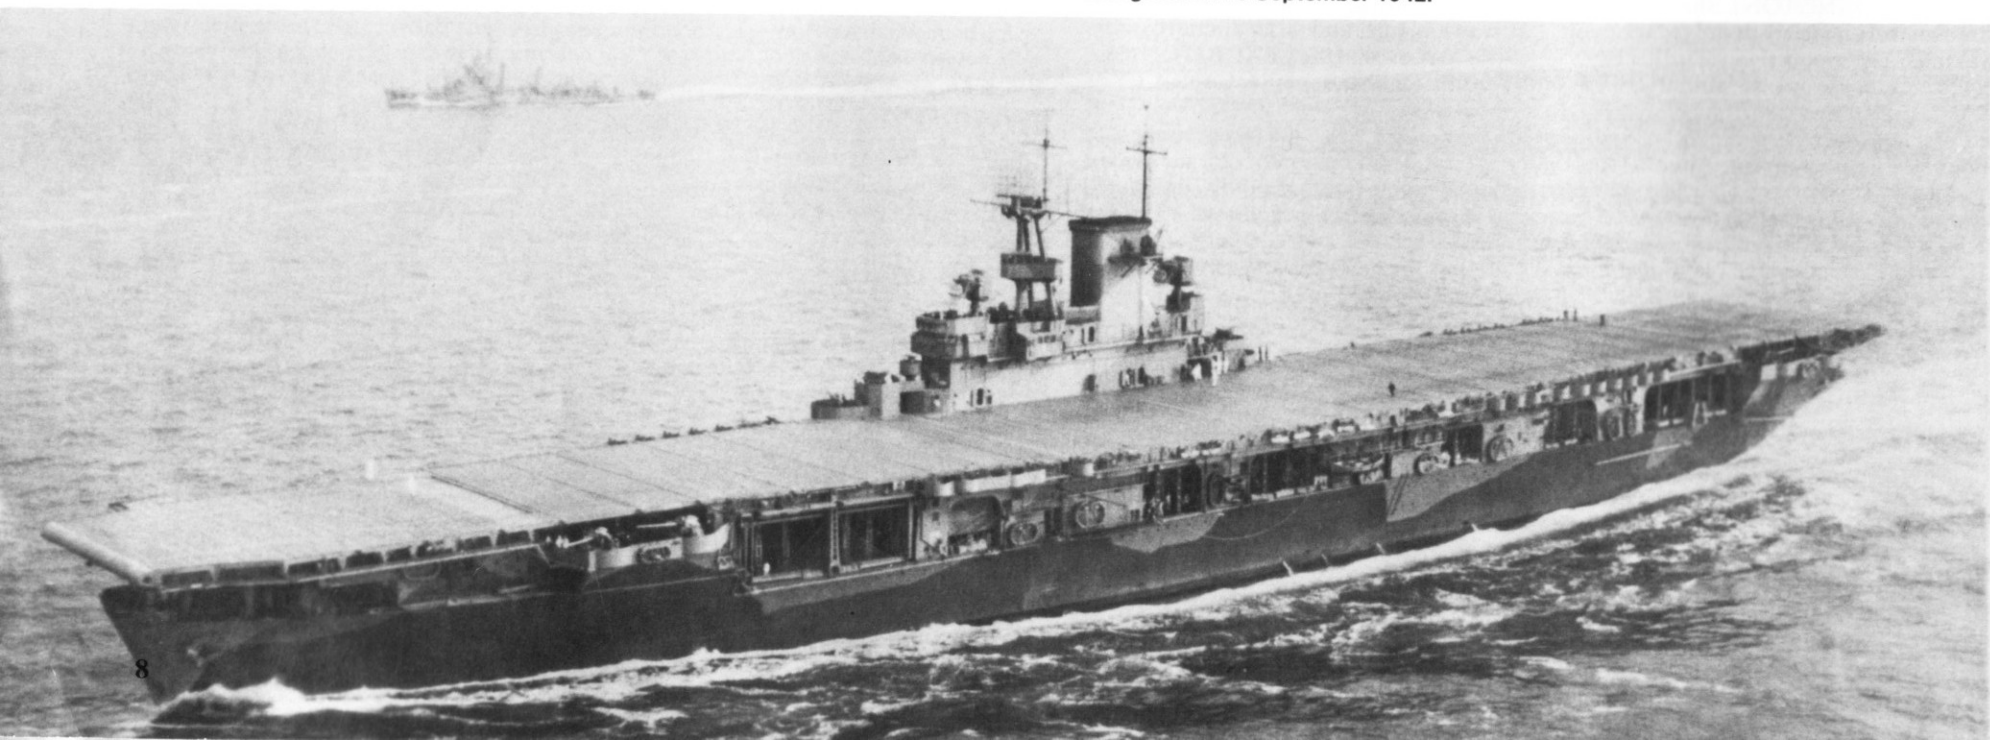
USS WASP was the last of the treaty carriers and her size was greatly restricted due to the remaining tonnage allowed under the terms of the Washington Treaty. WASP had a short career, being lost on 15 September 1942.

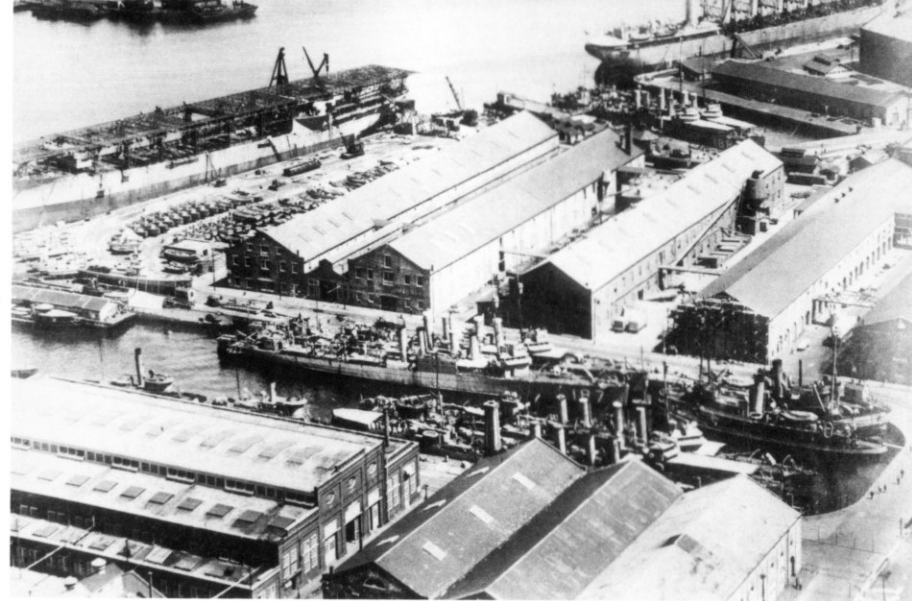
USS LANGLEY (1942)

USS LANGLEY was converted from the collier USS JUPITER at Portsmouth, Virginia. The ship in front of LANGLEY is another collier. LANGLEY had a similar array of cranes amidship which, when cut down, provided the main bracing for the flight deck. (USAF)

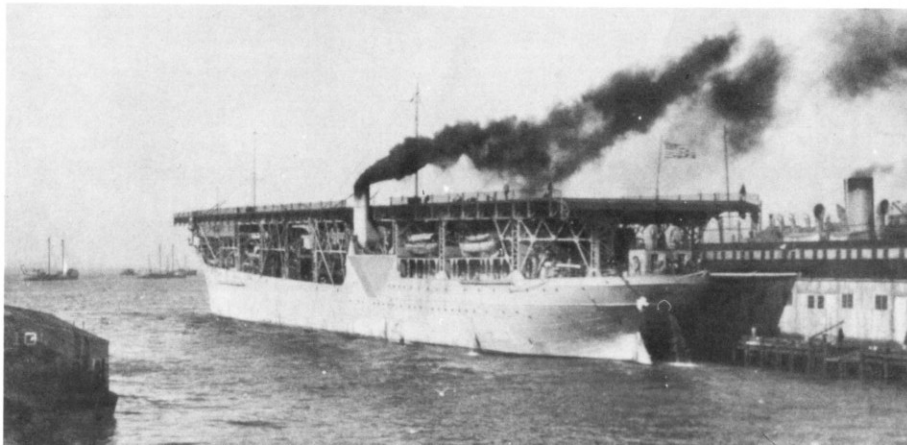
LANGLEY gets up steam while pier side at Hampton Roads, Virginia during June of 1923. Originally LANGLEY had a single large aft-folding funnel on the port side. This was soon replaced by the twin funnels, which she retained for the remainder of her career. (NARA)

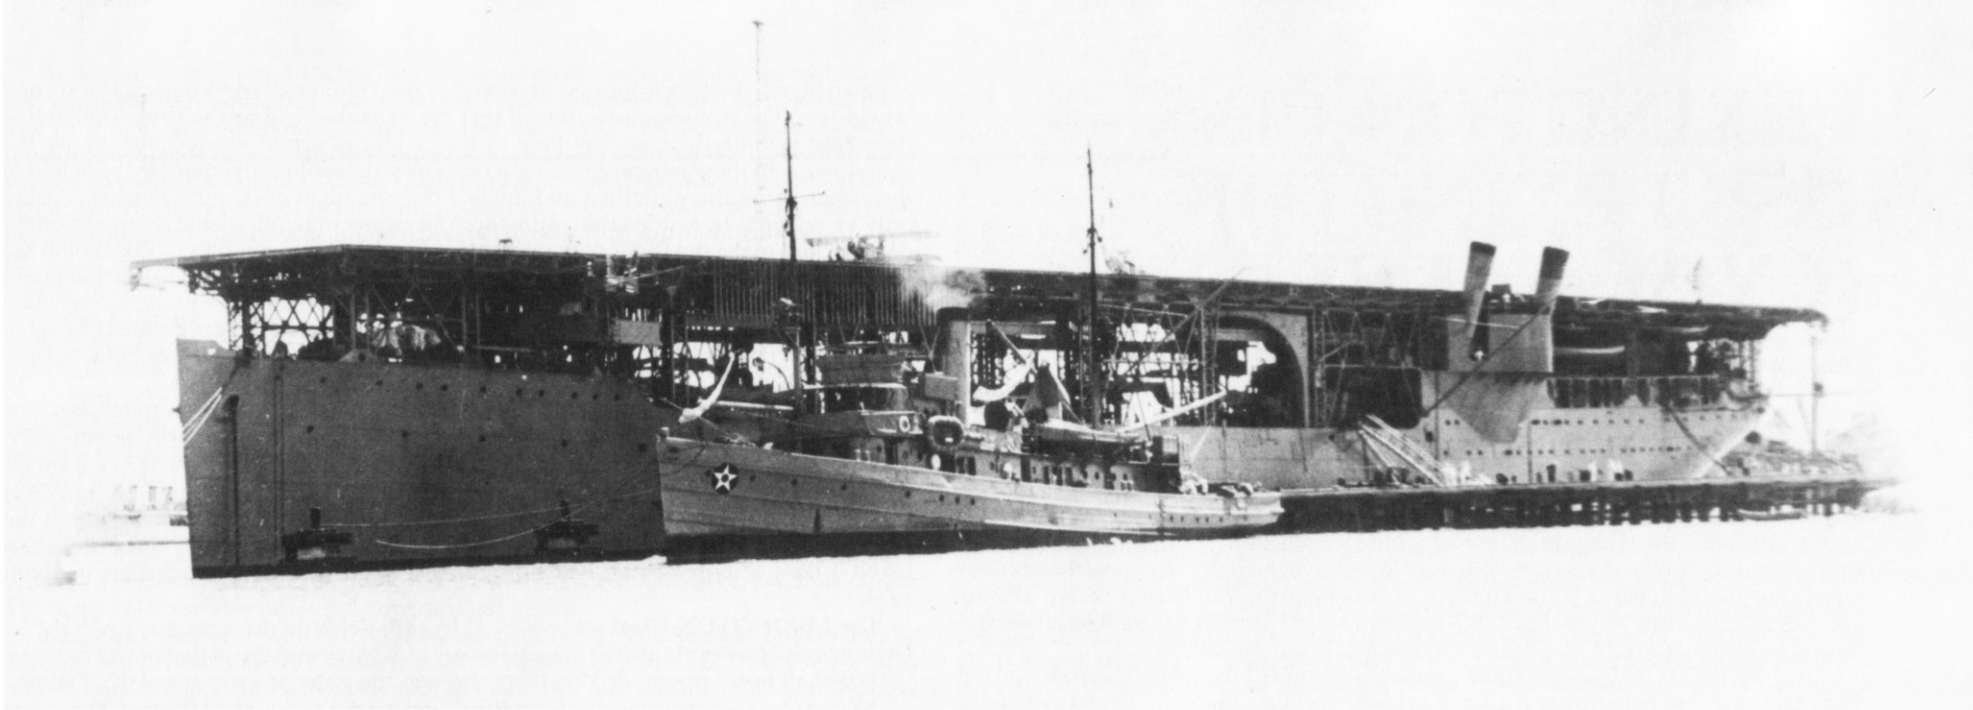
An aircraft tender is tied up alongside USS LANGLEY on 28 April 1925. The open nature of LANGLEY's hangar deck is clearly visible. The twin stacks folded downward into the cutouts visible just below the stack. (USAF)

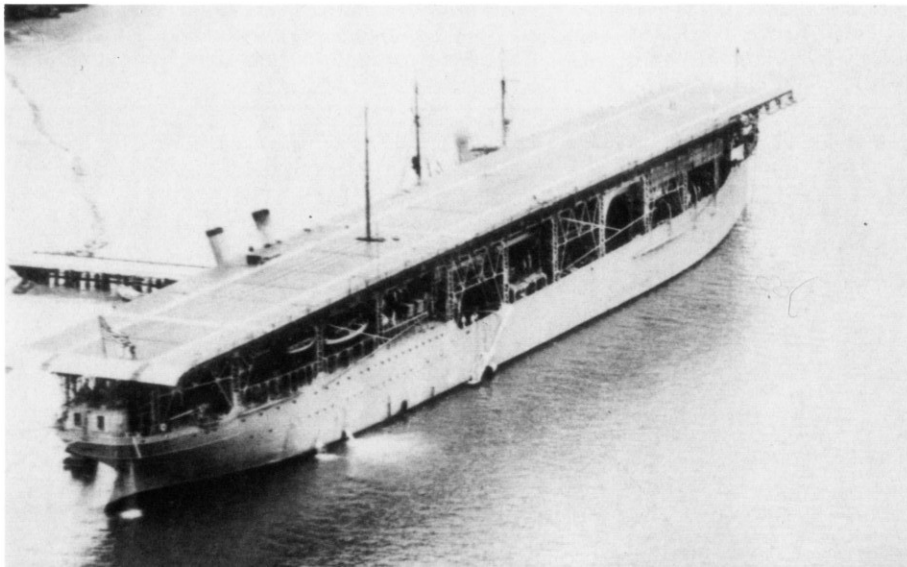
The same two ships seen from the other side a few days later. The ship had a temporary mast erected in the middle of the flight deck, which was removed when the ship put to sea. The two small masts that appear to be forward on LANGLEY actually belong to the tender. (USAF)

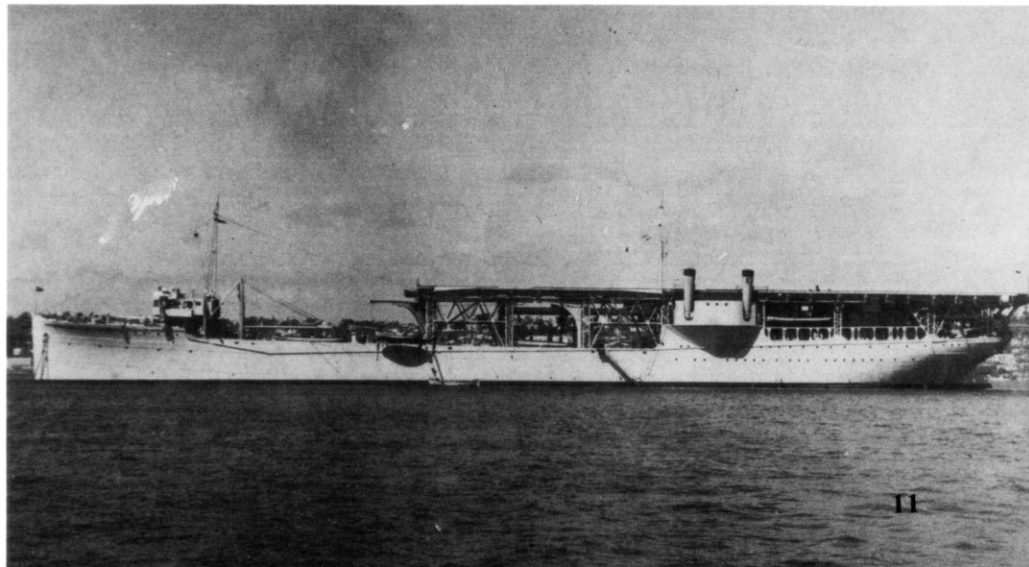
At the end of her career, LANGLEY was converted to a seaplane tender (AV 3) to free up tonnage for new construction under the Washington Treaty. LANGLEY was lost ferrying USAAC P-40s to Java during early 1942. (NHC)

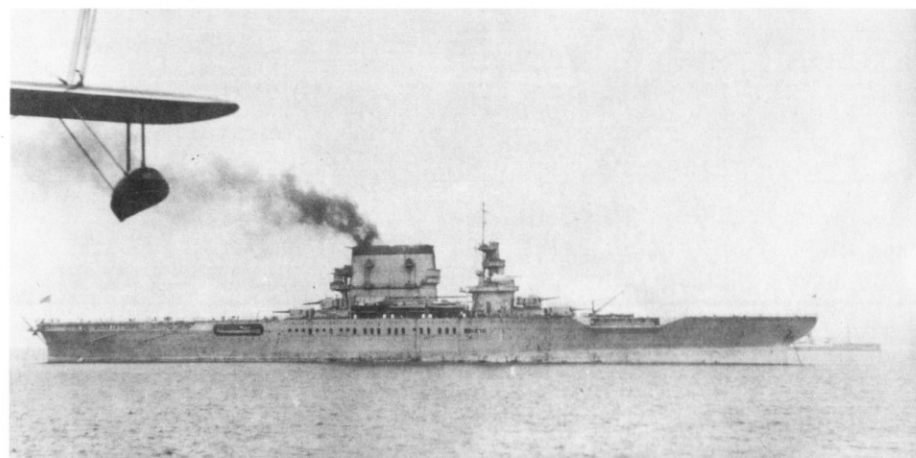
The USS LEXINGTON at anchor off Panama on 25 March 1928, was a significant addition to the fleet. The massive funnel, separated from the bridge, was a recognition feature of the LEXINGTON Class carriers. At this point she was armed with four eight inch twin gun mounts. (NHC)

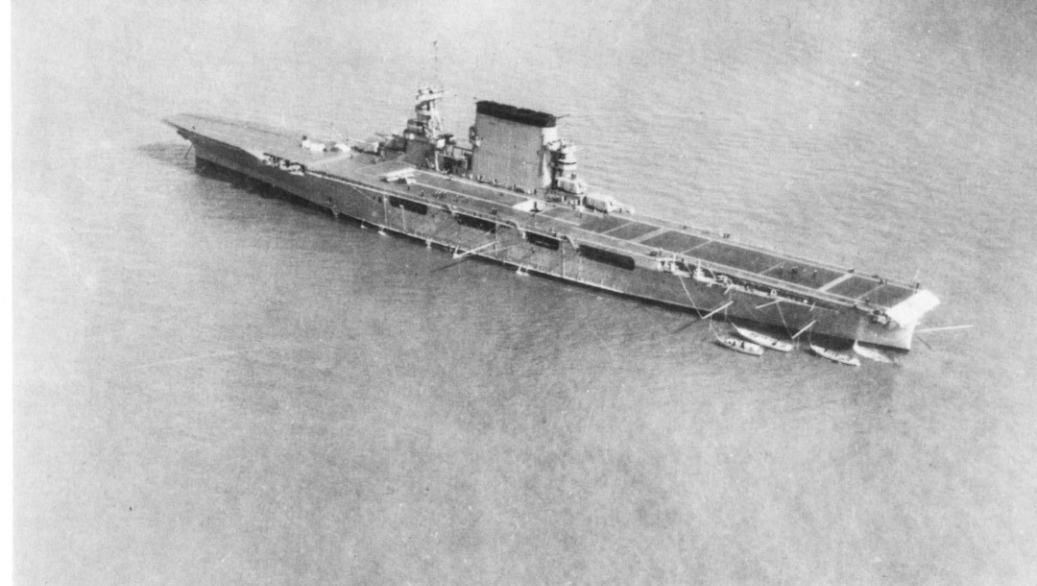
**The two sister ships of the LEXINGTON Class, USS LEXINGTON and USS SARATOGA were virtually indistinguishable. SARATOGA rides at anchor with a number of small boats moored aft. The small aft elevator, alongside the aft 8" gun mounts, is open while the outline of the larger forward elevator is visible abreast the bridge. The elevator arrangement proved to be a handicap and all subsequent fleet carriers had at least three. (USAF)**

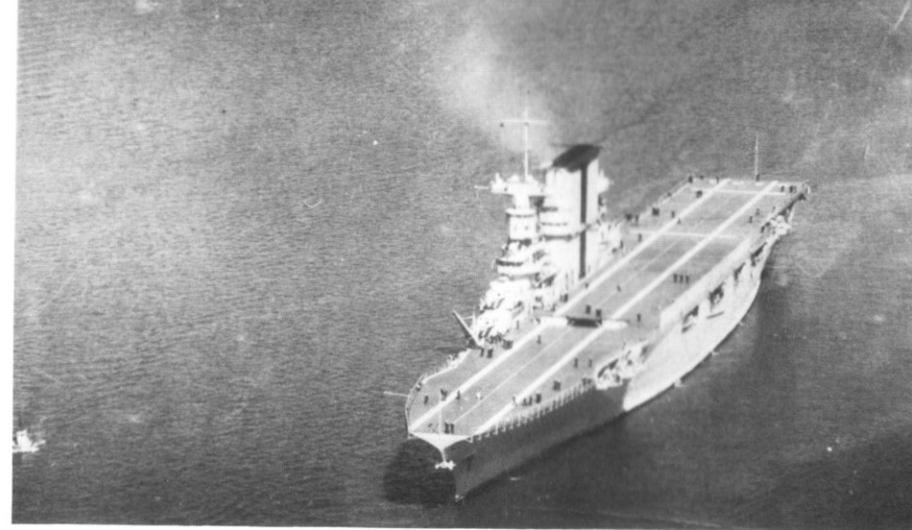
SARATOGA gets underway from San Diego, California during May of 1932. The Black funnel band and her nickname (SARA) in White on the round down make identification easy. The forward elevator is down. (NARA).

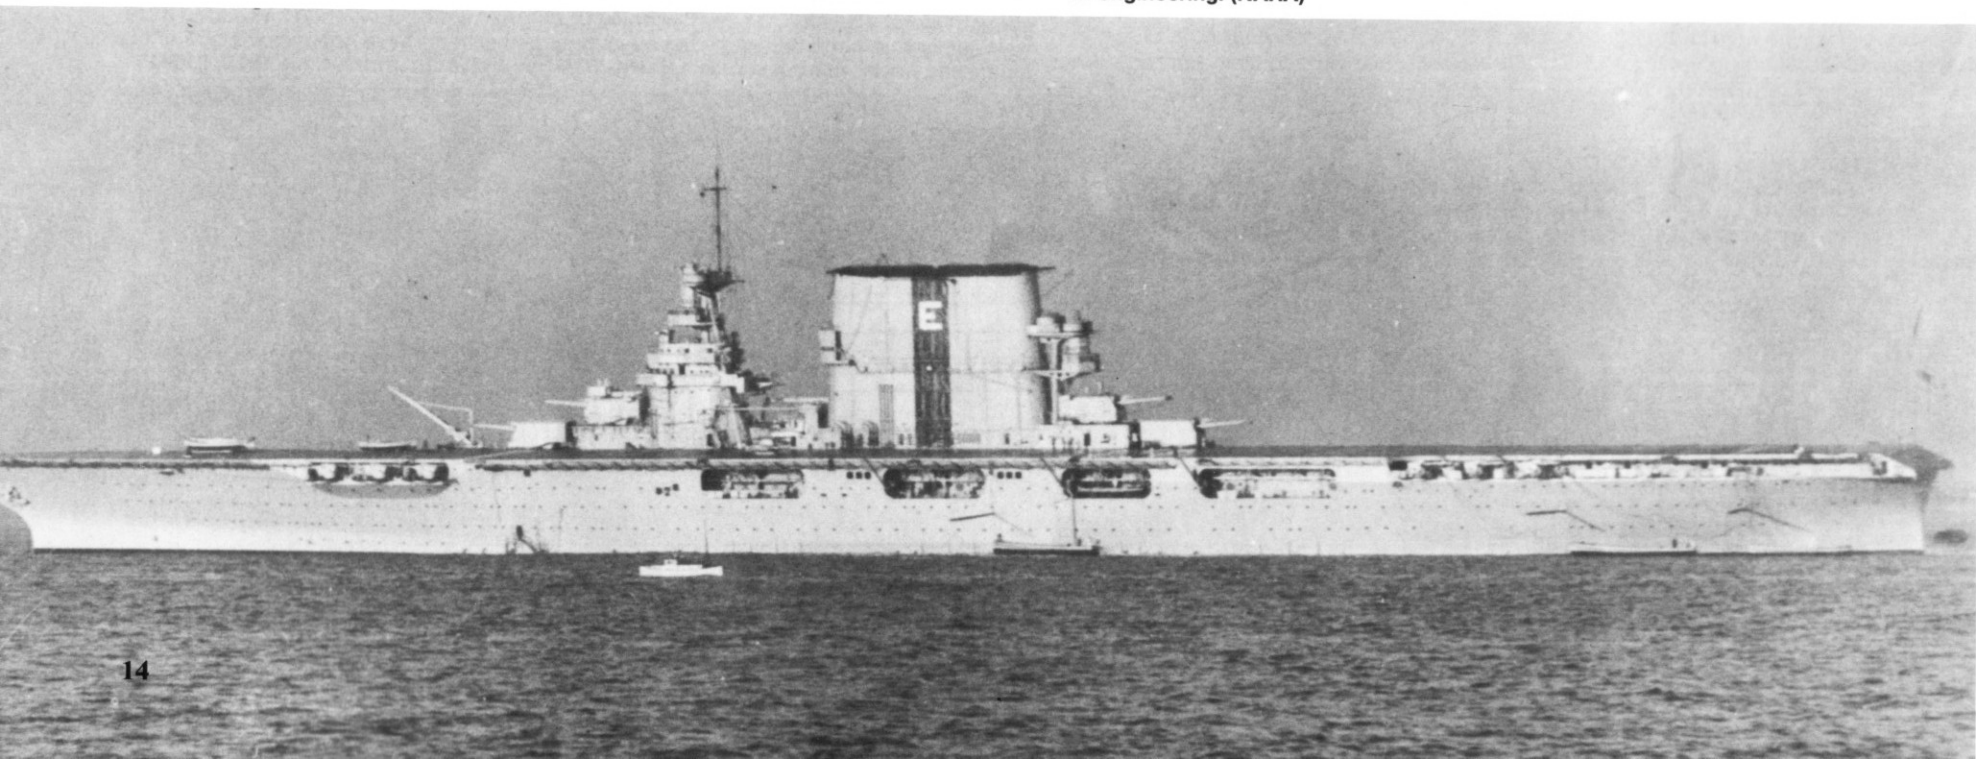
LEXINGTON was painted in Ms 1 and Ms 5 camouflage before the outbreak of the Second World War. At this time (14 October 1941), she still carried her 8 inch gun mounts, each topped by a pair of .50 caliber machine guns in gun tubs. She has replaced the catwalk on her funnel with a gallery of additional .50 caliber mounts higher up on the funnel. Additionally, the flight deck had been widened near the bow. (NARA)

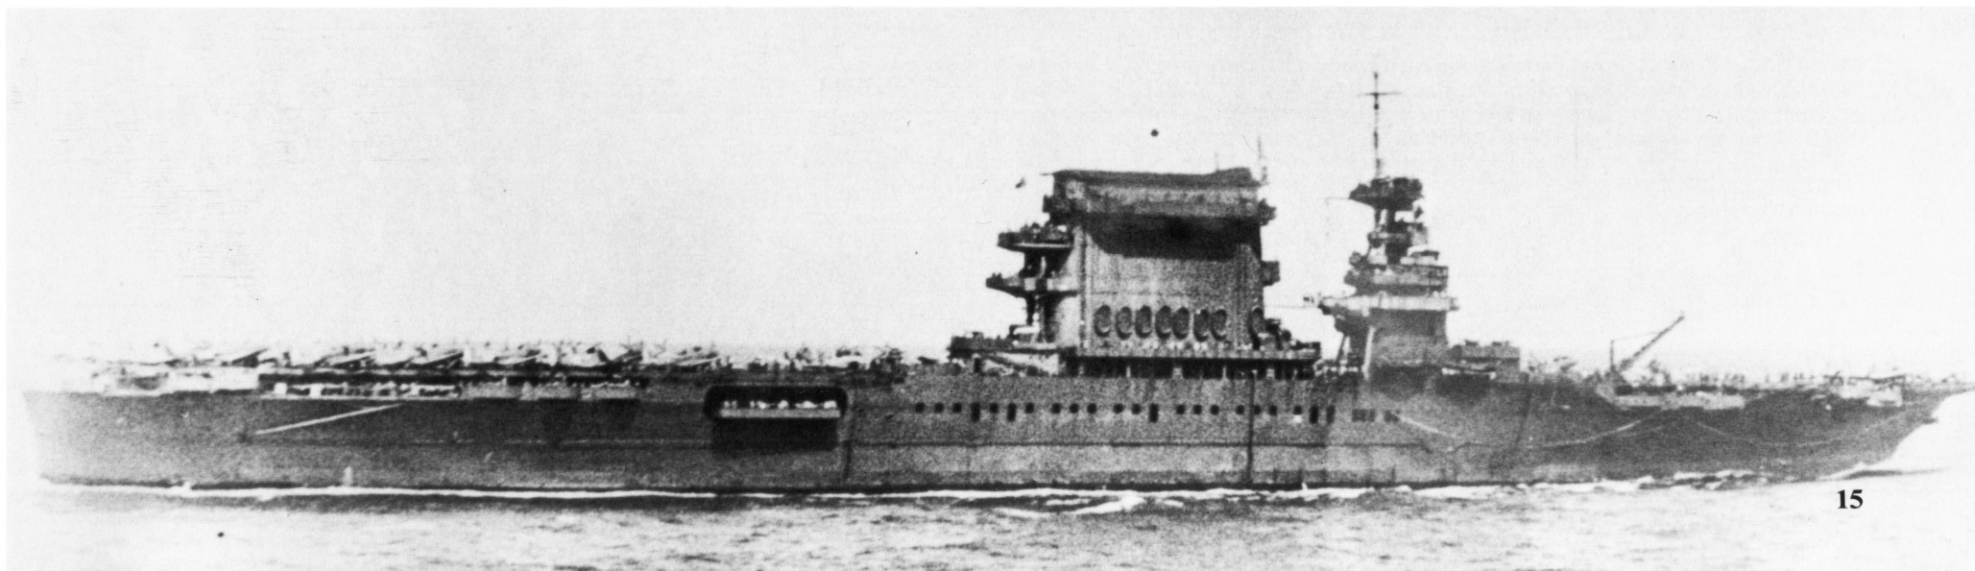
LEXINGTON is down at the bow due to torpedo damage sustained at the Battle of Coral Sea. She carries galleries for .50 caliber machine guns and single 20mm mounts run along the funnel at two levels and in the boat stowage space aft. Her 8 inch guns were replaced during April of 1942 by 1.1 inch quad anti-aircraft guns. CXAM-1 radar was added on the forward lip of the funnel. (NHC)

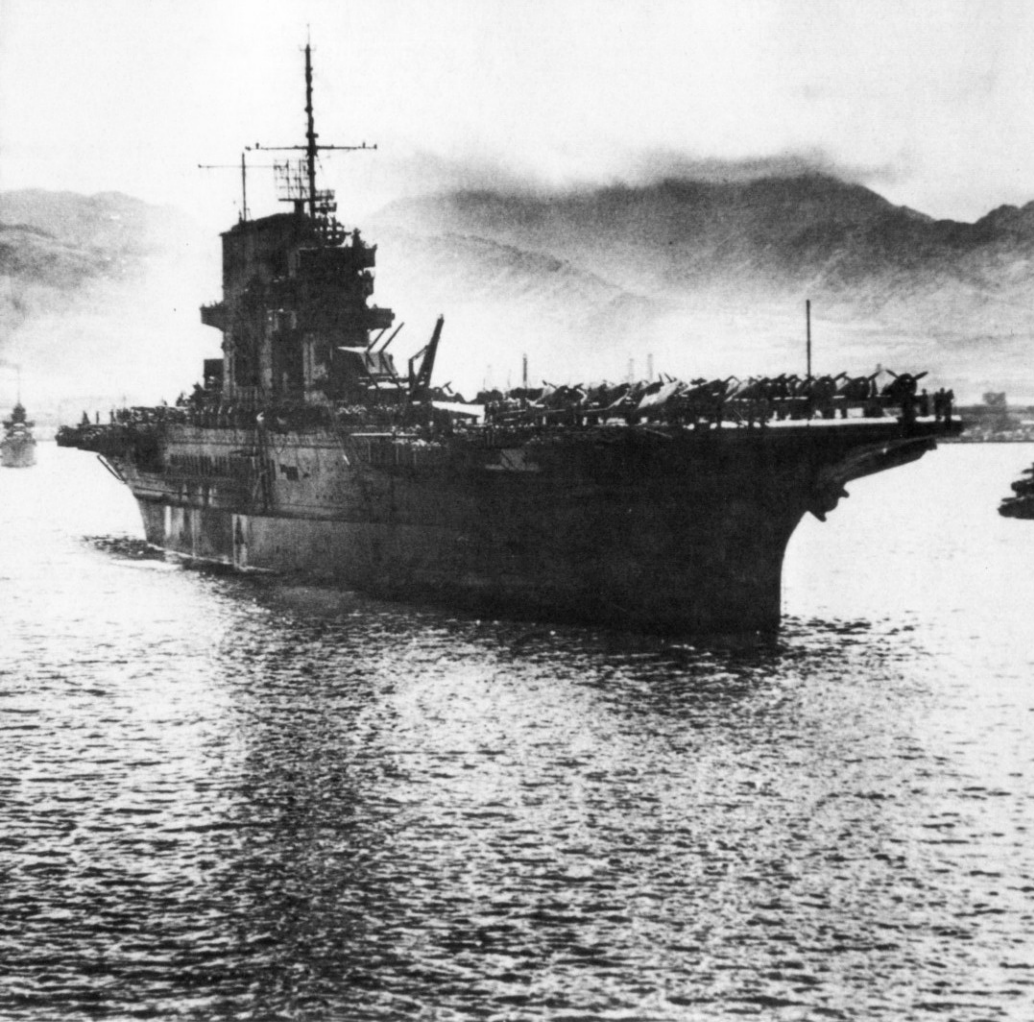
SARATOGA returned to Pearl Harbor following torpedo damage repairs on 6 June 1942. She has had most of the changes that were previously made to LEXINGTON, including the widened bow, CXAM-1 radar and the 20mm gun gallery decks (the .50 caliber guns were deleted because this gun was now accepted as useless for air defense). Additionally, she has had her 8 inch mounts replaced by 5"/38 dual mounts. Her bridge has been cut down and simplified and Mk 37 directors with FD radar have been added to control the 5 inch DP mounts. (NARA)

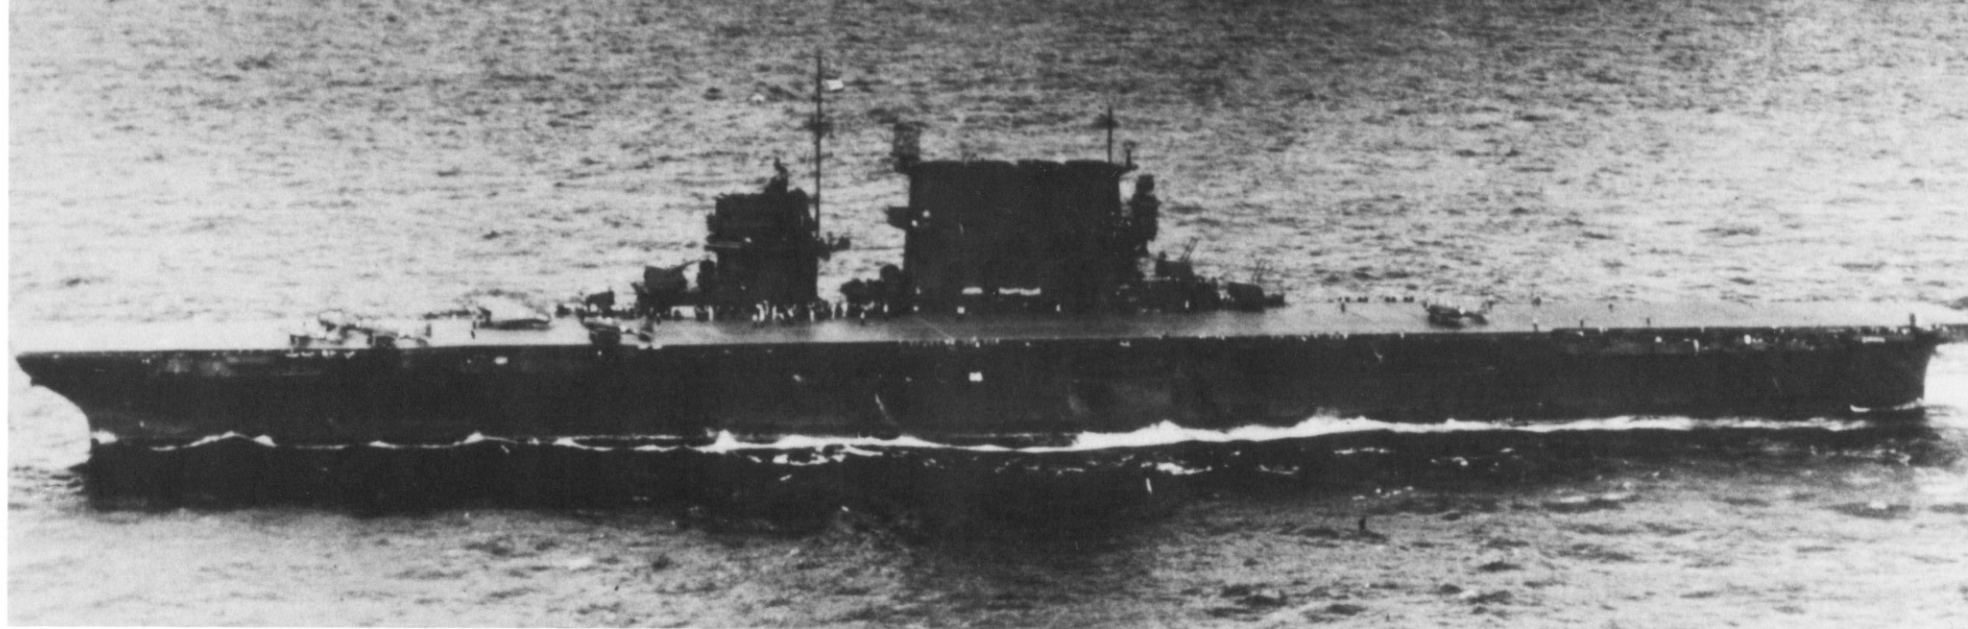
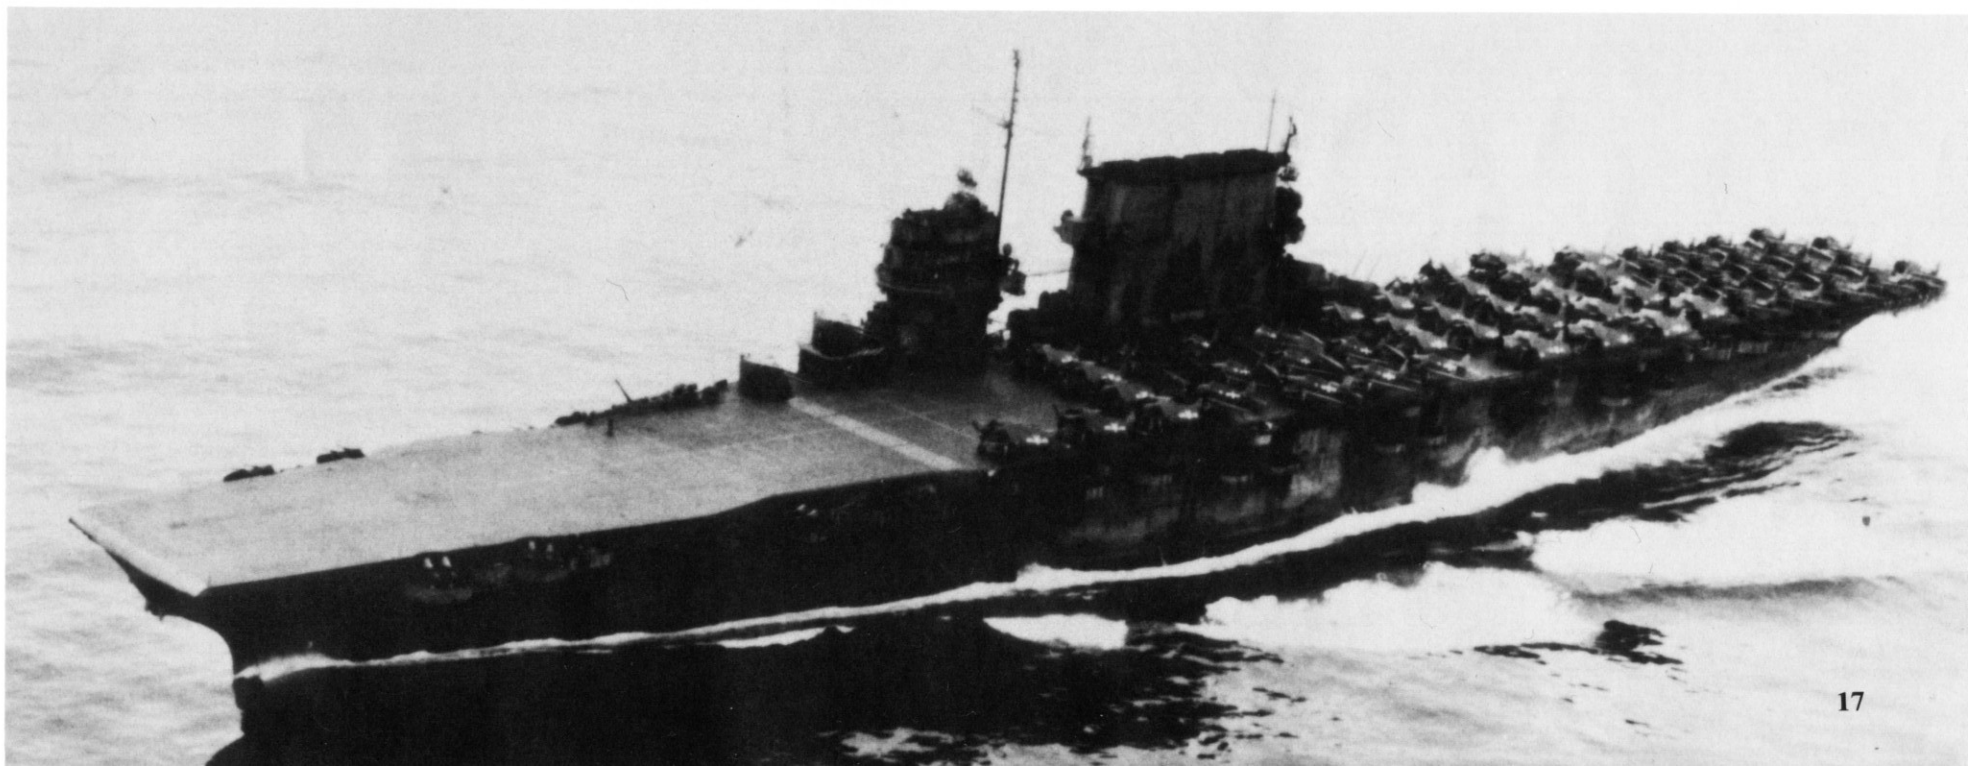
The SARATOGA during September of 1942 (above) and June of 1944 (below). The most noticeable change in the ship has been the addition of numerous quad 40mm gun mounts in individual sponsons along the sides. She retained, however, the outdated CXAM-1 radar antenna. (NARA)

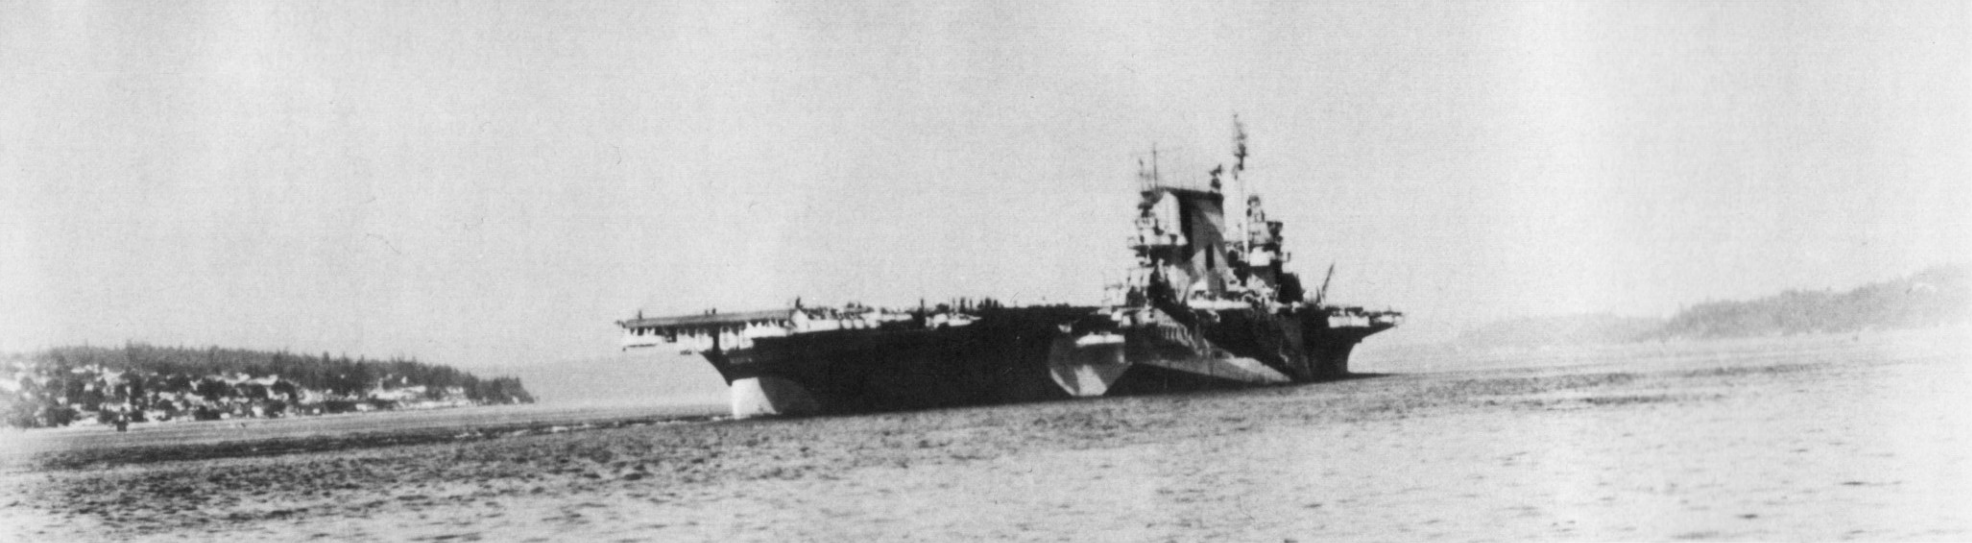
**SARATOGA** emerged from a major refit/overhaul during the Summer of 1944 with a distinctive Measure 32/11A camouflage. She has had her radar suite updated with an SK search radar antenna mounted on her foremast and an SM fighter direction radar antenna replacing the CXAM-1 antenna on her funnel. Additionally, there were quad 40mm gun sponsons suspended under the flight deck round down. (NARA)

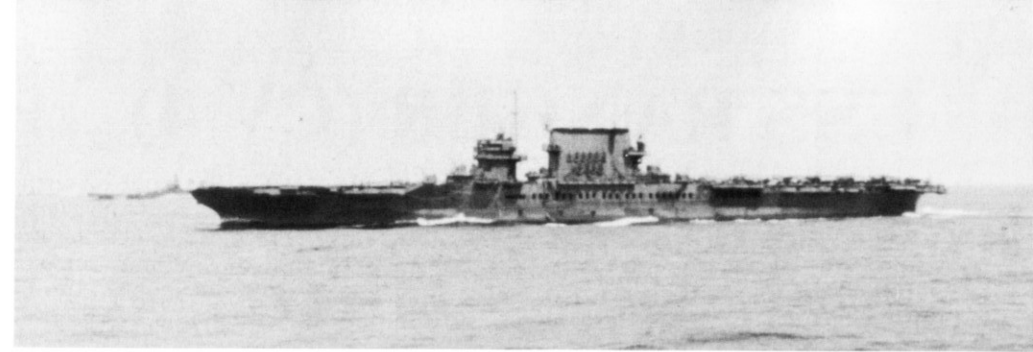
The White spots on SARATOGA's bridge on 22 February 1945 were shrapnel damage from a Kamikaze attack on 21 February. The SM radar on its substantial pedestal is mounted at the front edge of the funnel, while the Mk 4/22 radar combination on her bridge was unusual. The Mk 22 "orange peel" antenna was normally teamed with the later Mk 12 radar. (NARA)

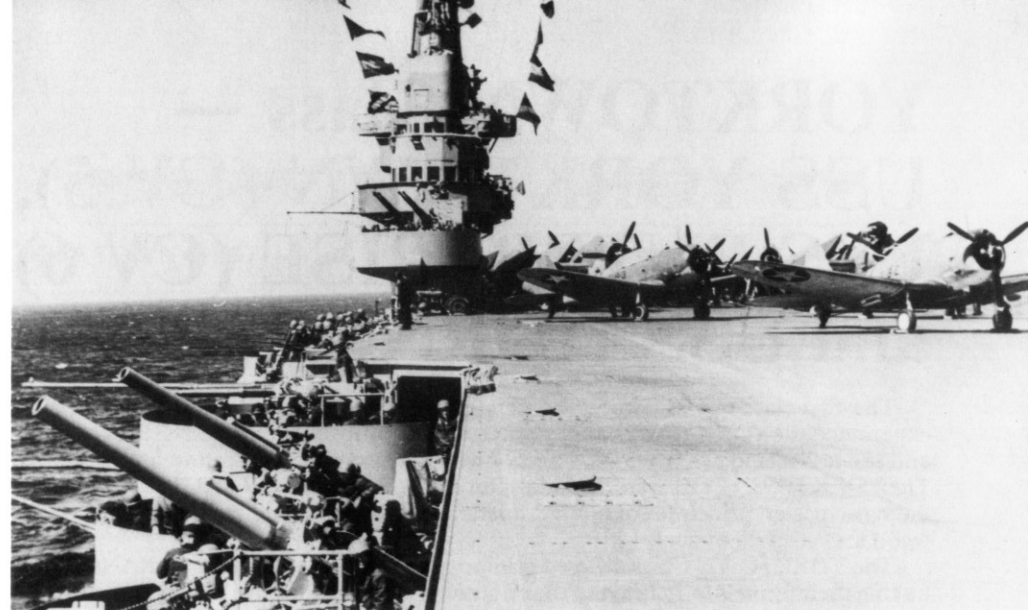
Serving as a training carrier, RANGER operated FM Wildcats, TBM Avengers and SBD Dauntless dive bombers. The crew is conducting a General Quarters drill with all 5"/25 gun mounts, 40 and 20mm guns manned with the crews in helmets and life jackets. (NARA)

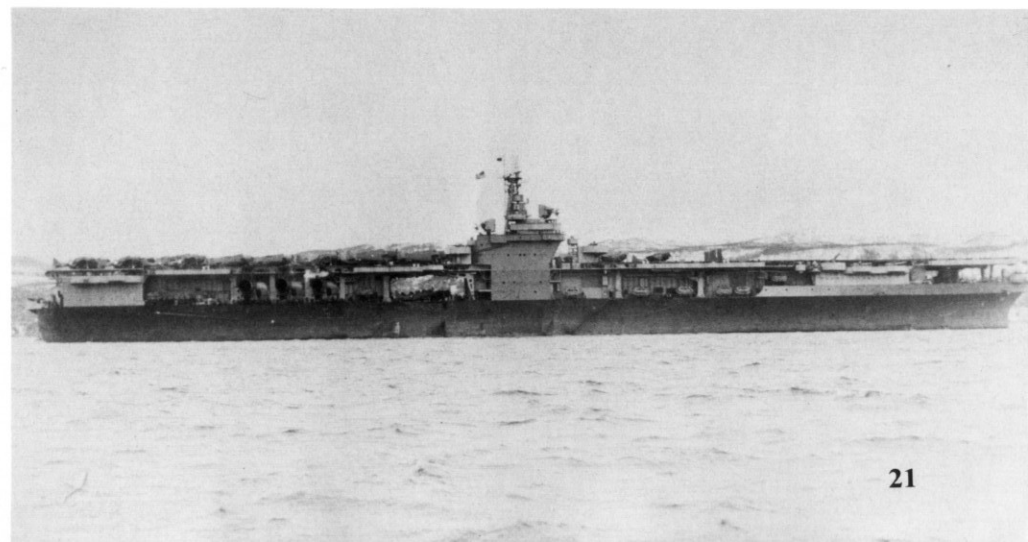
RANGER rests at anchor off Placentia on 10 April 1943. She is camouflaged in the mid-war Atlantic scheme, Measure 22. This was the camouflage that she carried for most of the war. Her folding funnels are tilted outward and she has 40mm quad gun mounts fore and aft of her island and on either side forward. (NARA)
